# WARFIGHTER SUPPORT

## Independent Expert Assessment of Army Body Armor Test Results and Procedures Needed Before Fielding

Highlights of [GAO-10-119](#), a report to congressional requesters

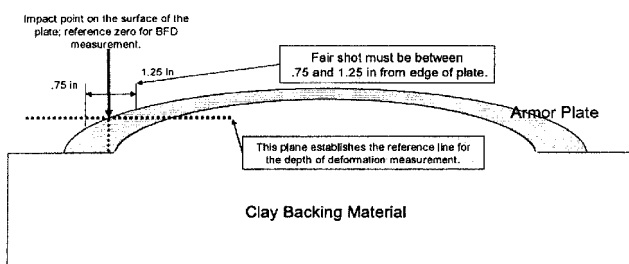
Figure 1. Test setup before test shot.

**Assertion 5** – Army tester's incorrectly measured the amount of force absorbed by the designs tested by measuring back-face deformation at the point of aim rather than at the deepest point of depression. (Page 5 of 48, paragraph 1; and, Page 21-23 of 48.)

**Response:** Though ATC deviated from the test protocol in the Purchase Description regarding measuring BFD at the lowest deformation, Army leadership after a deliberative internal process and in consultation with DOT&E, decided to use the BFD point-of-aim measurement as it was determined to be an accurate and repeatable process that did not bias any vendor's design. The following information highlights the rationale for this decision. For clarity and reference, Figures 1 and 2 depict the geometry associated with this issue. Further discussion follows the figures.

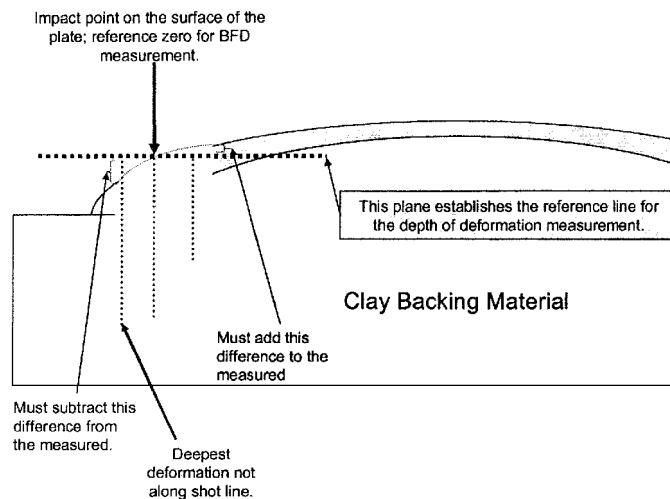
Figure 2. Post shot measurement.

The Purchase Description, Paragraph 4.9.9.3 Back-Face Deformation Measurement, states:

“Back-face deformations in the clay will not exceed 1.70-inches (43mm) max (Paragraph 3.9.3) when measured from the original undisturbed surface of the backing material to the lowest point of the depression. All Back-Face Deformation measurements will be conducted at 0 degree obliquity only. Indentation measurements will utilize measurement devices (+/-0.1 mm accuracy) incorporating a fixed reference “guide” (See Figure 2)<sup>14</sup> that can rest solidly upon two edges of the fixture, establishing the reference plane across the diameter of the indentation. The distance between the reference “guide” and original undisturbed surface will be measured at the point of intended impact prior to impact. The distance between reference “guide” and the lowest point of depression will be measured after impact. Back-face deformation will be the difference between the two.”

Referencing the first sentence of the above quote, the only known reference point prior to a test shot is the aim point (“original undisturbed surface of the backing material”). Prior to the shot, the test technician has no way of knowing the surface location perpendicular to the lowest point of depression. The fixed reference guide identified in the quote, shown in Figure 3, can only assist in establishing the aim point as

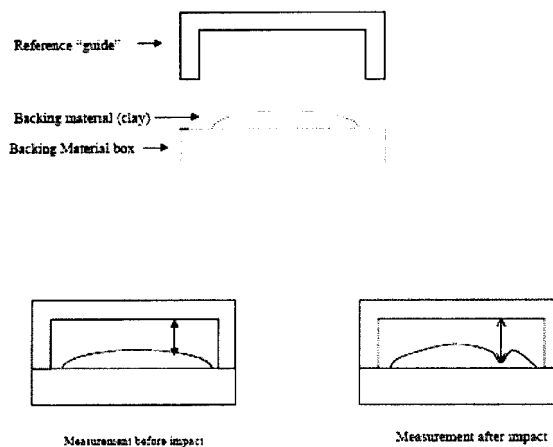
Figure 3. BFD Measurement Reference Guide from Purchase Description.

There are two important considerations pertaining to the guidance in the Purchase Description: First, the lowest point of depression must be subjectively selected by a test technician, and second, measuring perpendicular from the point selected as the lowest point of depression to the reference guide provides the distance between that point and the original undisturbed surface at the aim point, not the original undisturbed surface perpendicular to the lowest point of depression, which is what is required to obtain an accurate measurement. Using the technique described, an accurate measurement can only be made if the measurement is made on a flat surface with a uniform original undisturbed reference surface. However, since the plates are curved and the radius varies between vendor plates and even within vendors for same plate sizes, as shown in Figure 4, the only point at which an accurate measurement can be made with the described measuring device is the aim point.

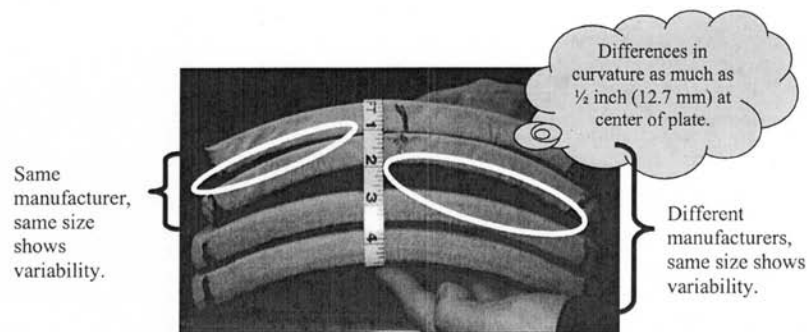
Figure 4. Picture illustrates variance in curvature between same size ballistic plates.

Although not contained in the Purchase Description, PEO Soldier had an internally documented process to account for plate curvature when the deepest point of deformation was laterally offset from the point of aim. However, due to plate curvature variance, a correction factor only approximates the deepest deformation measurement. That is one reason ATC elected to measure BFD at point of aim at the beginning of testing, but also became the rationale for a better procedure using the laser scanner as explained elsewhere in this letter.
